# REPORT 5607

## ENGINEERING BULLETIN

### MK 7 MINECRUISER BRAKES

**Service Brake Failure**

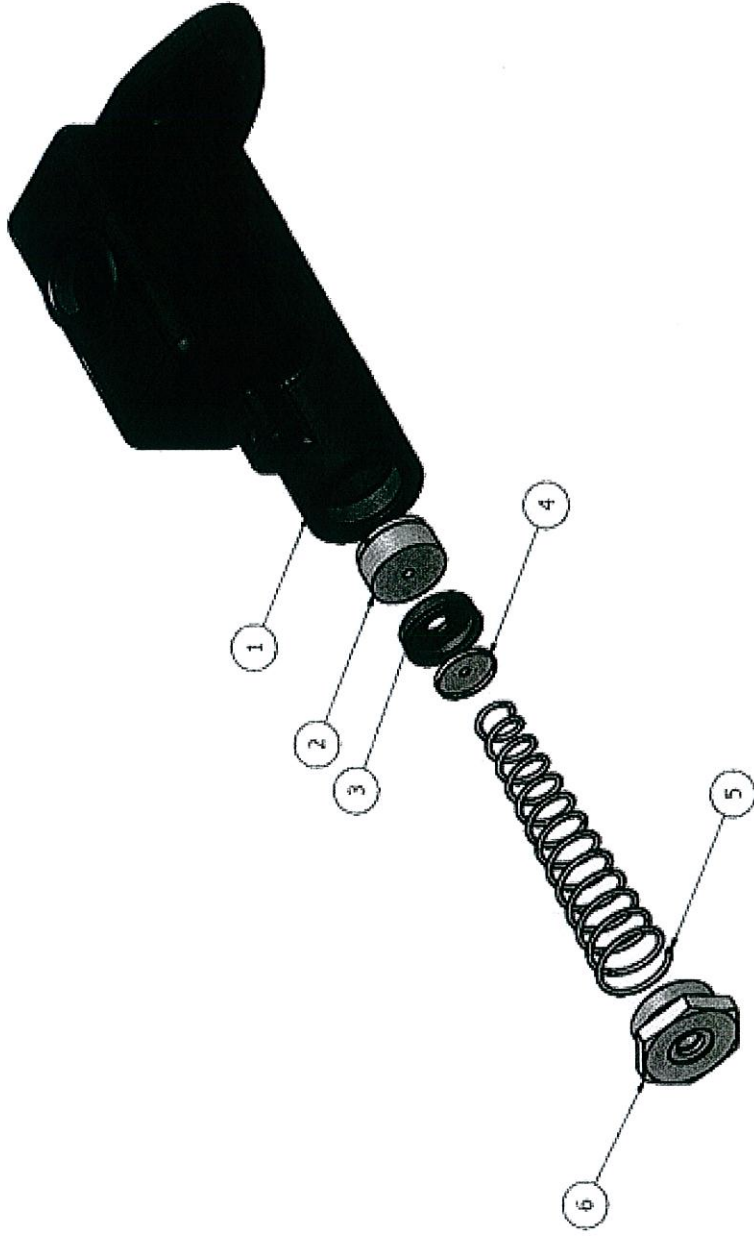
MASTER CYLINDER  
MINECRUISER

Investigation into separate Mk7 Minecruiser brake issues has determined that a faulty master cylinder hydraulic seal 7-091035-703 (see Appendix A) has caused the service brake to fail. The seal failure has been recorded and shows the service brake pressure decaying over time in response to a steady pedal pressure signal (see appendix B).

The manufacturer of the master cylinder recently changed the supplier of the seal, whereafter failures have occurred. This quality issue will be addressed by the supplier, including an inspection and test program for all future units.

- Remove Item 6. Warning - this part is under spring compression tension from item 5. While work can be performed by hand, some caution must be taken.
- Remove Item 5.
- Remove Items 4, 5 and 2 as one assembly.

- Ensure that all components are clean.
- Coat Items 2, 3 and 4 with a mineral based hydraulic oil.
- Slide Items 2, 3 and 4 into the bore of the master cylinder.
- Ensure that Item 4 remains inside the cup section of Item 3.
- Use Item 5 and push Items 2, 3 and 4 all the way into the bore.
- Install Item 6 and torque to 75Nm.
- Some caution must be taken with the tension in the spring. Items 5 while assembling Item 6.

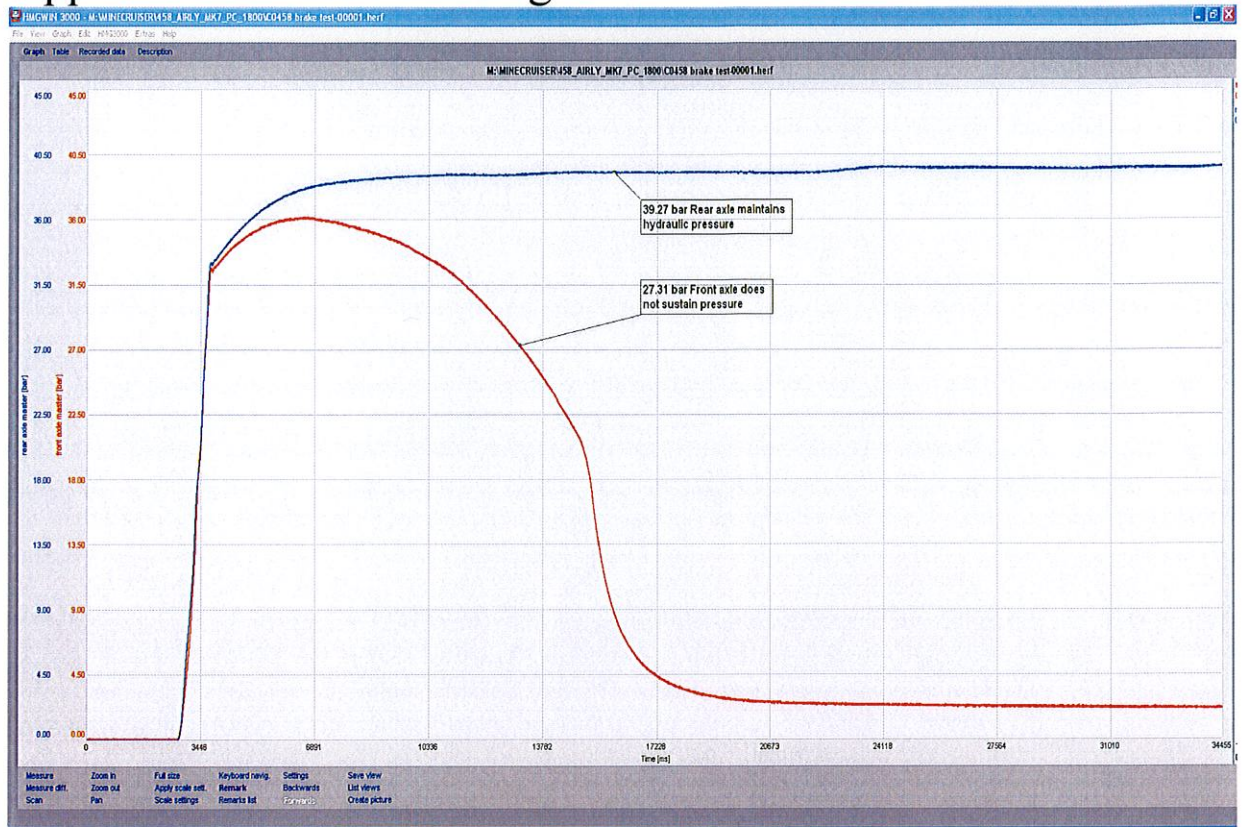
Graph 1. Data Log showing master cylinder seal failure recording

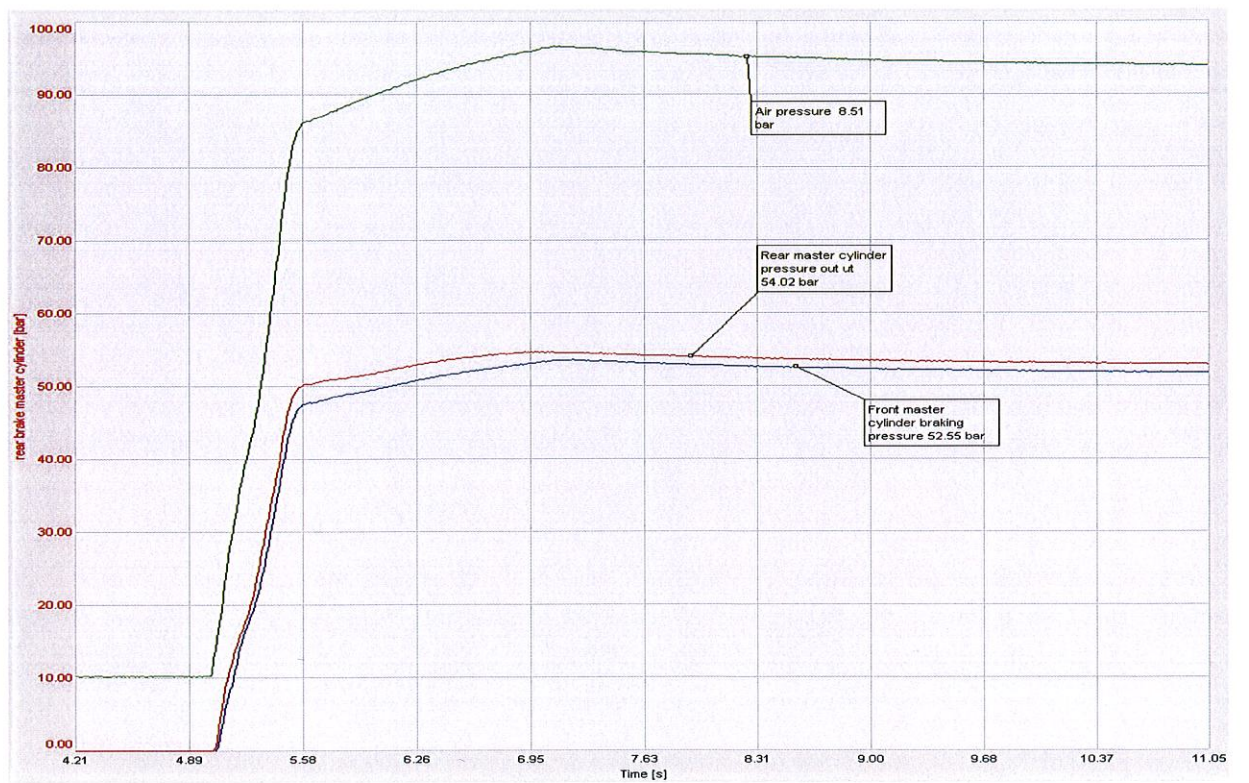
Graph 2. Data log showing master cylinder correct operation after seal replacement.

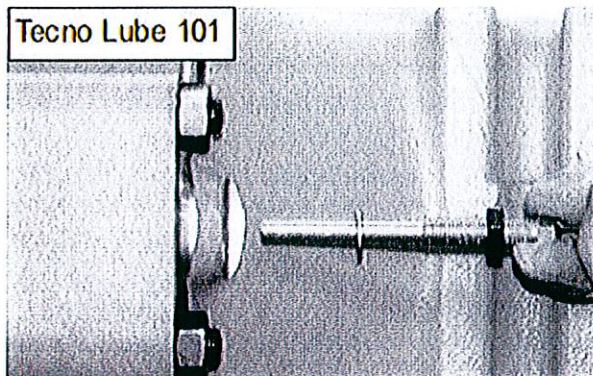
In course of this investigation it was also found that the Brake jacking screws were adjusted incorrectly, causing reduced brake torque on application. Please refer to Appendix C for the correct 34 mm adjustment procedure that will allow full compression of the axle brake.

**FIGURE 4:** Remove screws complete with nuts and seals. Replace seals, apply silicone-based Tecno Lube/101 grease to the screws and install all parts into the arm.
