PRODUCT TECHNICAL BULLETIN 36366 TRANSVERSE ARM WELD FAILURE

Date: 26-08-2024
Issue: A
Prepared for: Industry

Applicable machines: MineCruiser Mk6, Mk7

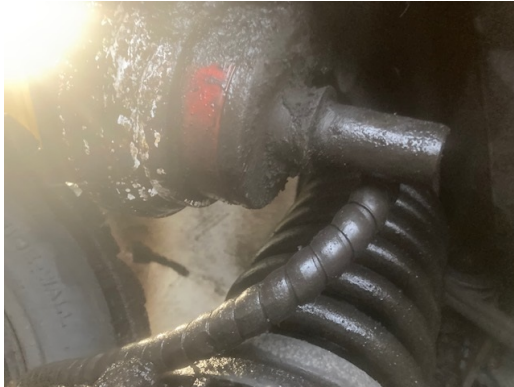
The MineCruiser Mk7 and Mk6 are installed with solid axle suspension which consists of an A-frame, springs and transverse arms. Recently, cougar were notified of a failure of a transverse arm that resulted in the separation of the welded pin and tube assembly. The failure was identified during routine servicing.

Figure 1: Pin end showing failed weld and exposed internal rod

1. Cougar recommends inspection of front and rear transverse arm assemblies, with particular attention to the weld at the pin and tube connection. The joint should be cleaned and visually inspected for weld cracking or damage at the next available service opportunity.
2. As per the Mine cruiser maintenance schedule, visual inspection of suspension components should be done daily.
3. A more detailed inspection of this joint, as described above in point 1 is recommended monthly after initial inspection.
4. Repair is recommended by replacement

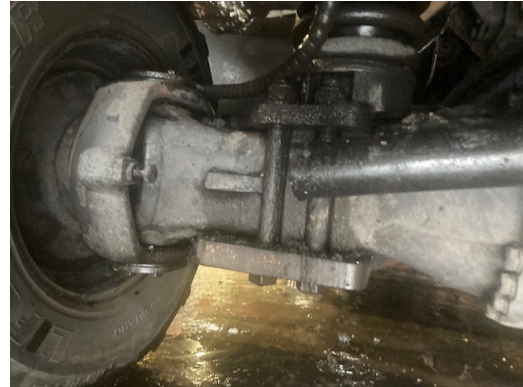
Figure 2: Open tube on opposing end hanging near front differential

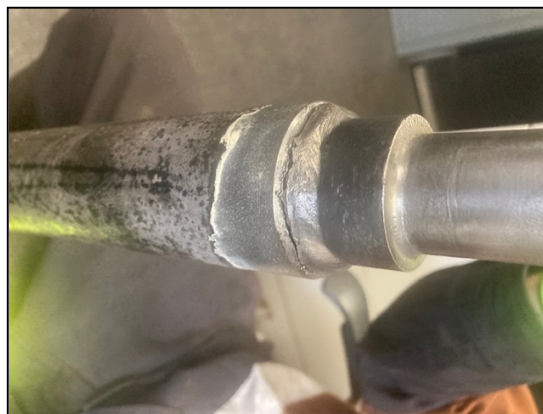
Figure 3: Cracked weld at pin/tube joint weld
