Quality System Work Instruction

Negative switch relay addition procedure -
Alternator

C-ExW 15

The purpose of this document is to inform suitably qualified, competent electricians of the correct procedure for retro fitting the additional isolation relay required by GE Mining Industrea's bulletin 30435.

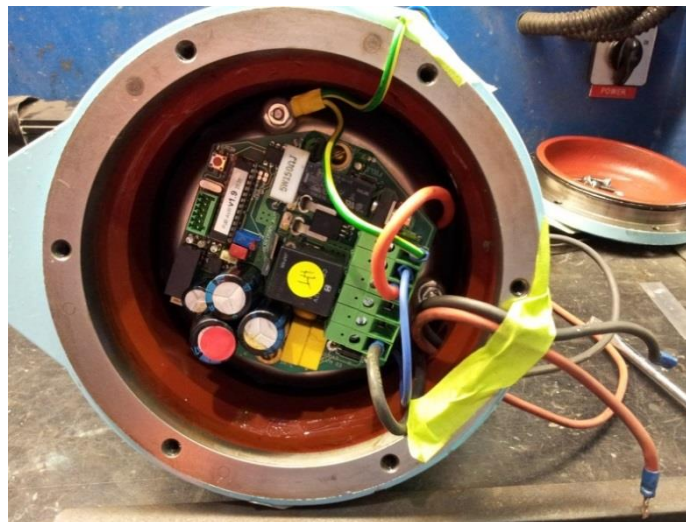
Alternator with rear cover removed, load wiring disconnected and tethered out of the way

Detach the rear cover from the alternator by removing all of the M6 fixing screws and using 2 M6 x 40 cap head set screws as screw jacks in the threaded holes in the rear cover. Disconnect load wiring +ve and -ve wires from the terminal block terminals labelled "OUT+" and "OUT-" and tether the wires out of the way with tape or equivalent. The outgoing earth connection should be checked for security but may remain intact.

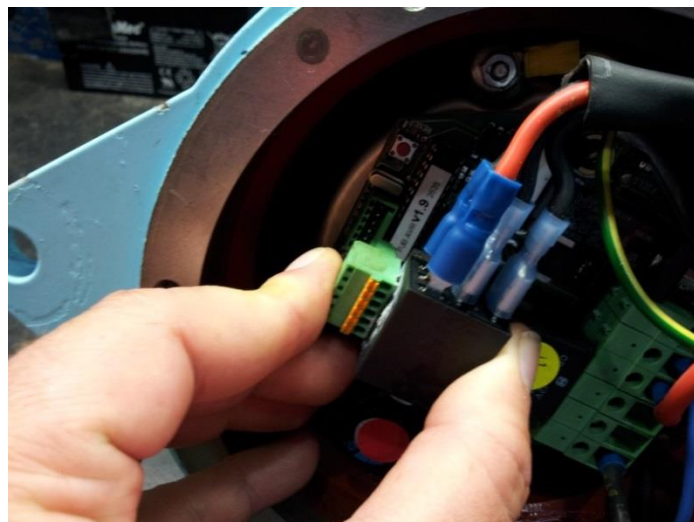
Fitting the relay assembly by engaging the attached plug into the pcb mounted socket

Fit the relay to the pcb by fully engaging the attached plug fully into the vacant socket on the pcb.

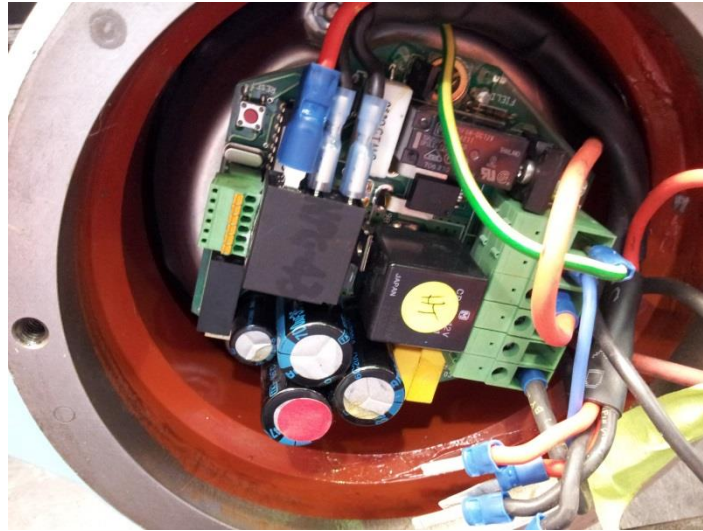
Retrofit relay harness tucked into the recess surrounding the internal rear cover.

Tuck the retrofit harness firmly into the recess surrounding the internal rear cover. All wiring must be kept as recessed from the rear as practical, while ensuring that the relay and the connections to it remain intact. Indication LEDs must remain visible.

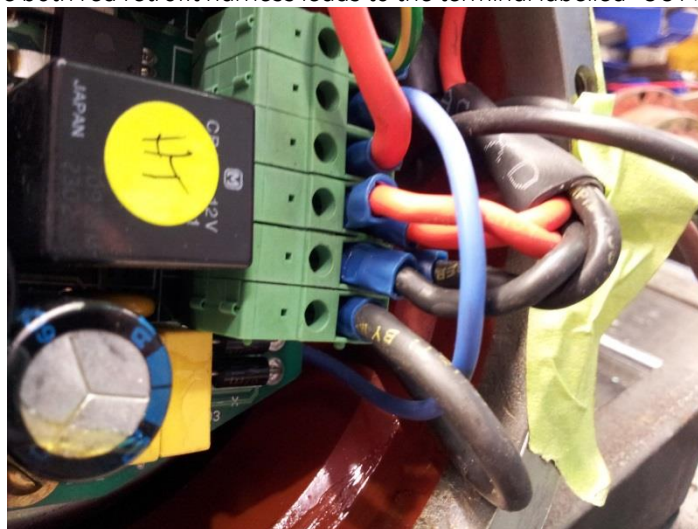
Retrofit kit wiring connected to the PCB

Fully engage and secure both black retrofit harness leads into the terminal block terminal labelled "OUT-" on the PCB. Then fully engage and secure both red retrofit harness leads to the terminal labelled "OUT+" on the PCB

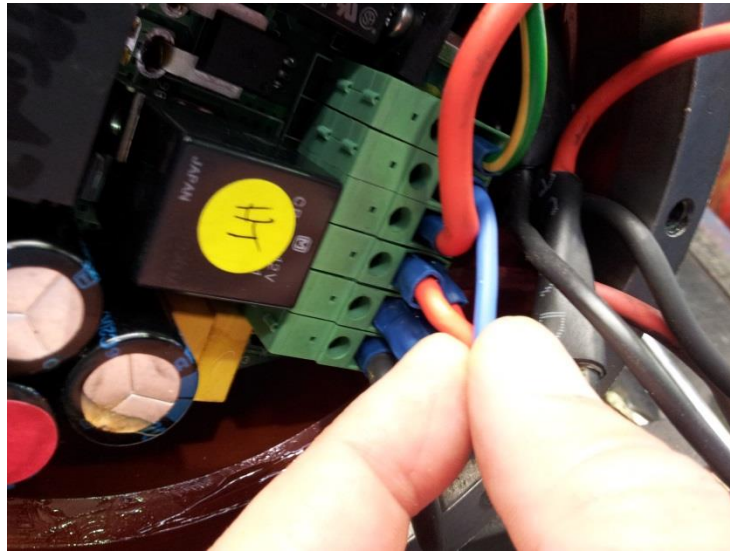
Retrofit kit wiring connected to the PCB

Check the security of each wire into the terminal strip.

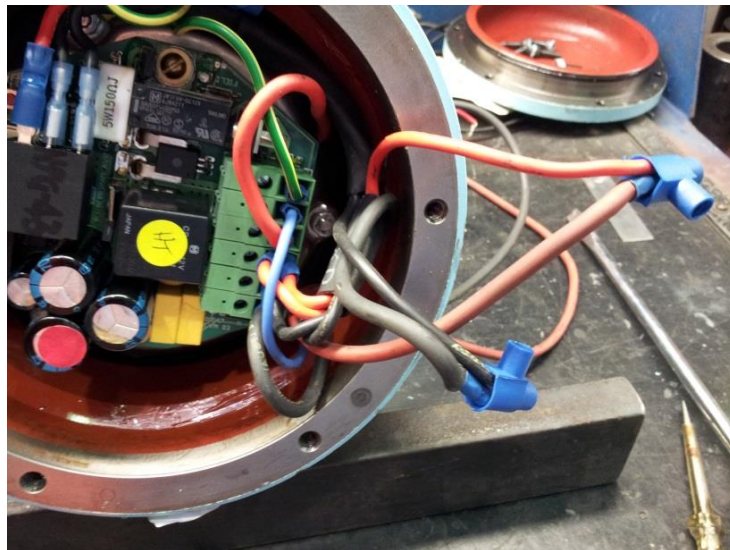
Retrofit kit wiring connected to the PCB

Connect the load wiring to the blue BP connectors, NOT to the PCB mounted terminal strip.

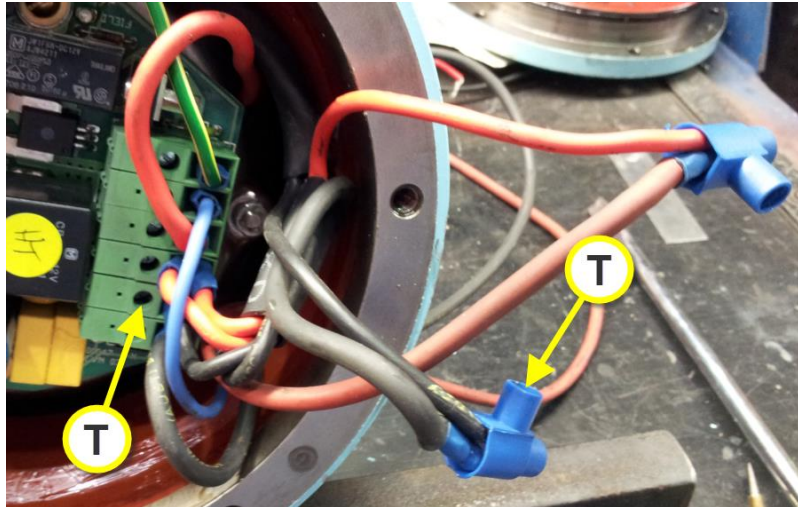
Continuity test points

Perform a continuity test between the test points shown in the picture below. MUST be open circuit. Tuck the wires into the housing so that there is no risk of pinching when the rear cover is re-installed.
