PRODUCT IMPROVEMENT NOTIFICATIONS GRADER

Date: 13-07-2021
Prepared for: Vehicle Owners
Prepared by: Bill Davidson

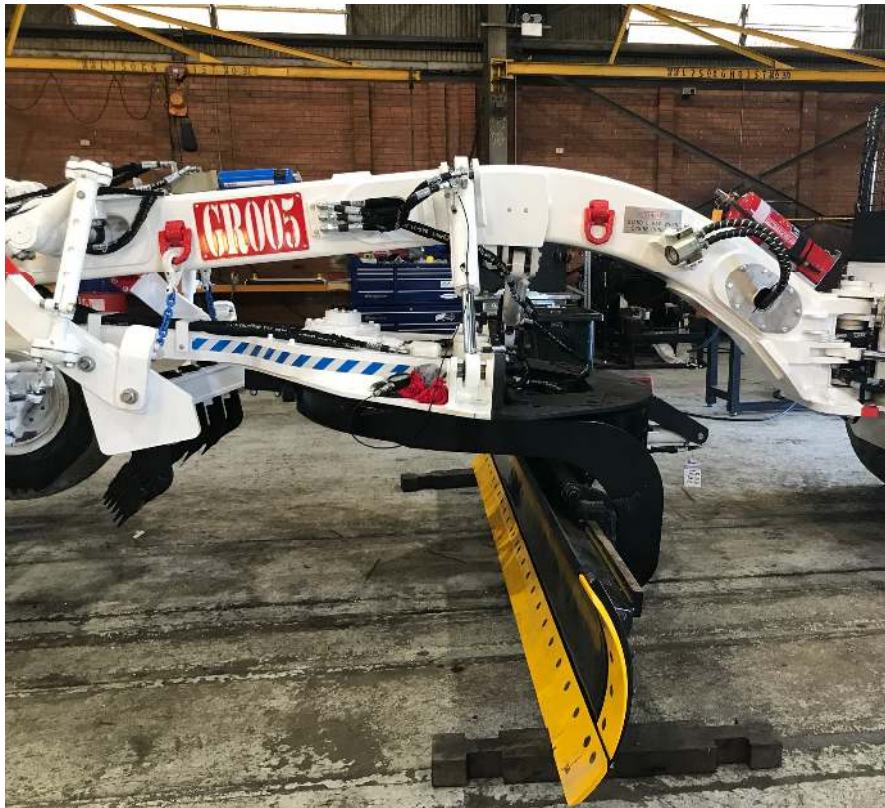
Figure 1: Bent Beam Grader

The beam assembly structural improvement significantly extends the fatigue life of the structure. Finite Element Analysis indicates upwards of 500% improvement to the original design.

Additional to the structural improvement, ball joints used for lift and lateral movement of the blade assembly have been changed to replaceable pin joints.

A significant visibility improvement is also evident on the high cab versions of grade due to the improvement to the line of sight for the operator.

Front axle assemblies, turning circle and blade assembly remain unchanged. The existing drawbar connection is modified to convert the ball joint into a double clevis. New cylinders and pins are required for lift and lateral shift.

This improvement is done in conjunction with the articulation hitch upgrade. Reference Grader Bent Beam upgrade when requesting quotation on this improvement.

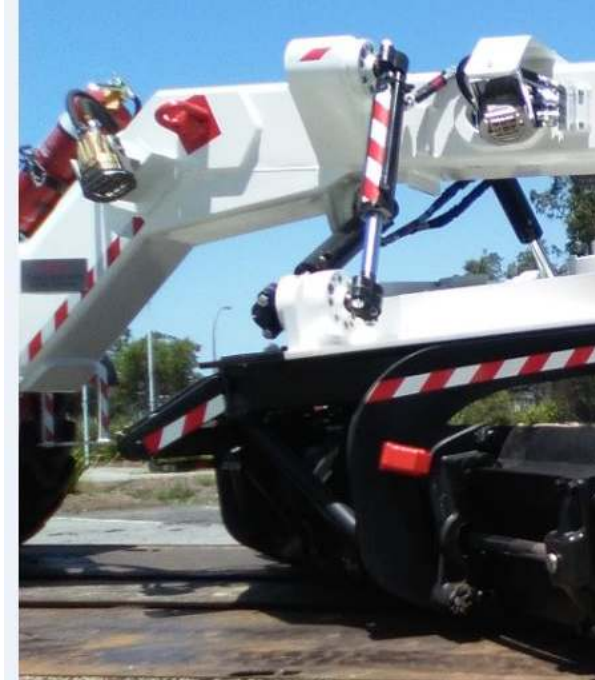
Figure 2: Bolt on ball stud arrangement

An improvement to the servicability of the ball stud attachment has been made by the design of a bolt on ball stud arrangement for side-shift & lift cylinder attachments

The fitment of the Bolt on ball stud requires a change to the beam attachment point and blade circle group attachment point by welding a tapping pad and spigot for the bolted ball stud to mount. The hydraulic cylinder design is unchanged.

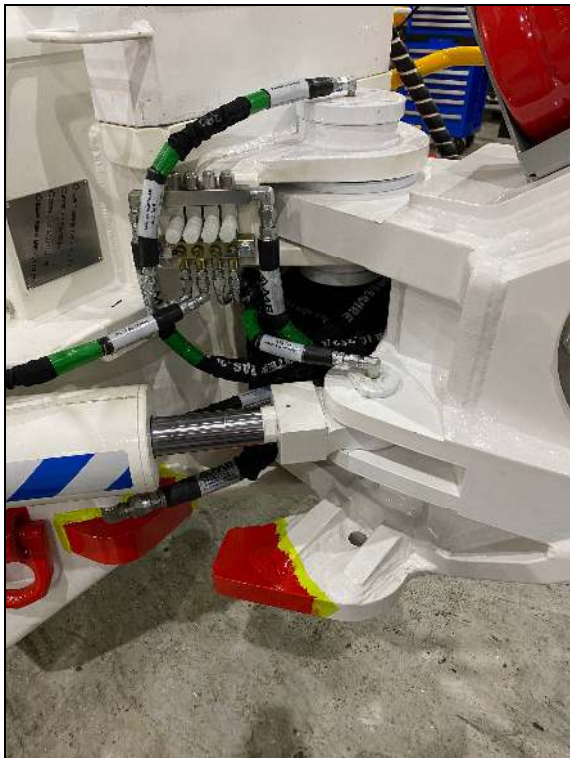
Figure 3: Upgraded Hitch Articulation

The articulation king pins are now retained via counterbored socket head cap screws rather than a single bolt. This allows a reduced interference fit of the pin into the casting to help with assembly and disassembly. Additionally the upgraded spherical bearings are now held captive into the bore via a retaining plate, reducing bearing movement and wear between the hitch bores and outer bearing race. Additionally a more robust articulation stop has been designed to prevent damage to steering cylinders when the end of stroke is reached.

The fitment of the new hitch arrangement is retrofittable to existing hitch castings, with some machining required on both the prime mover hitch and the beam hitch casting.

Additionally, higher rated bearings, bearing spacers and pins are required. This upgraded hitch assembly has been proven in service and is distinguishable by the flanged articulation king pins.

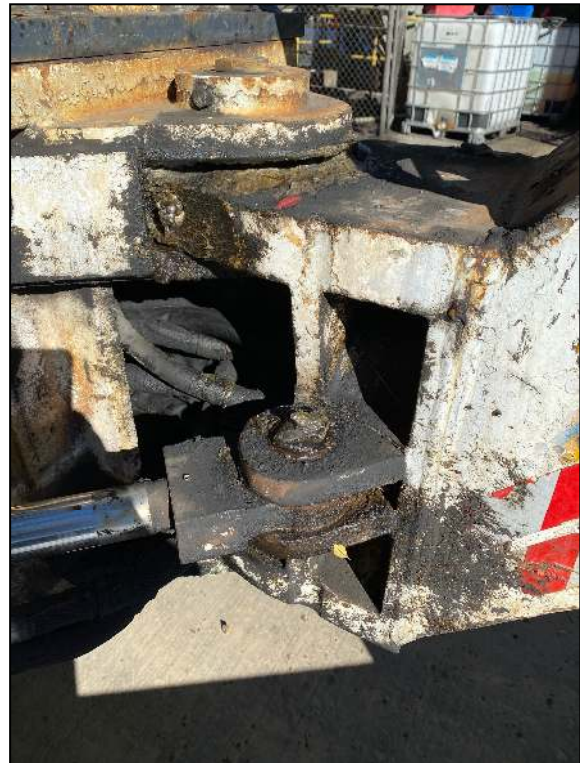
Figure 4: Old style hitch

A improved Hitch assembly has been developed for the grader to improve bearing and hitch casting service life, as well as reduce ingress of foreign material. The former hitch design relies on an interference fit of the king pins and a single retaining bolt. The hitch bores are likely to be damaged during disassembly. The bearings also rely on an interference fit into the bore to be retained. If wear of the outer race or bore occurs, movement of the bearing and subsequent collapse are likely outcomes.

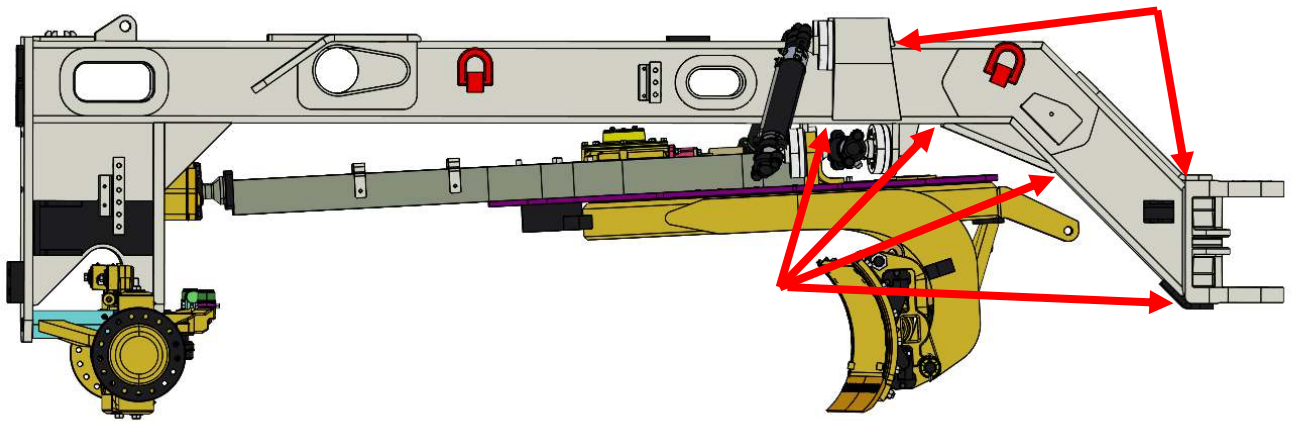
Figure 7: Straight Beam areas of detected cracking

Instances of fatigue cracking have been detected in service on Grader Straight beam areas as indicated. If left un adressed, crack propagation may lead to catastrophic failure of the beam, particularly at the SHS transition plate.

The fatigue life of the original front beam structure has been analysed and design improvements have been implemented, greatly reducing the probability of crack initiation and propagation.

Design improvements are reflected in Grader front beam weldment part number 7-023788-700 revision D or later.
